## STRUCTURAL INTEGRITY RESERVE STUDY

### Harborside Terrace

4200 Belaire Lane

**Project Number: 2324043**

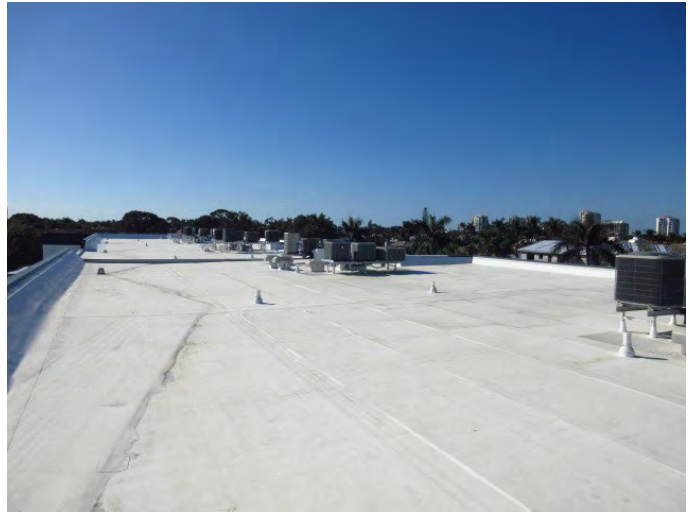
**PHOTO 7**

| Item | Description/Observations/Comments |
|---|---|
| Roof | <p>The main roof consists of a low-slope system (flat) covered with a thermoplastic polyolefin (TPO) single-ply membrane. Mansard roofs are wood framed, covered with standing-seam metal panels.</p> <p>The North-side low-slope roof section was replaced in 2020 and the South-side section in 2022. The mansard roofs were reportedly replaced in 2021. TPO roofs have an EUL of 20 years and pitched metal roofs have an EUL of 40 years. TPO replacement funds have been allocated throughout the reserve period.</p> <p>Please note that the extent of the roof evaluation did not include any sampling and/or testing involved therefore comments made regarding the condition of the roof are limited to visual observation as well as historical information. Should a more comprehensive investigation be required, the services of a certified roofing consultant should be considered.</p> |

GENERAL VIEW OF ROOF COVERING

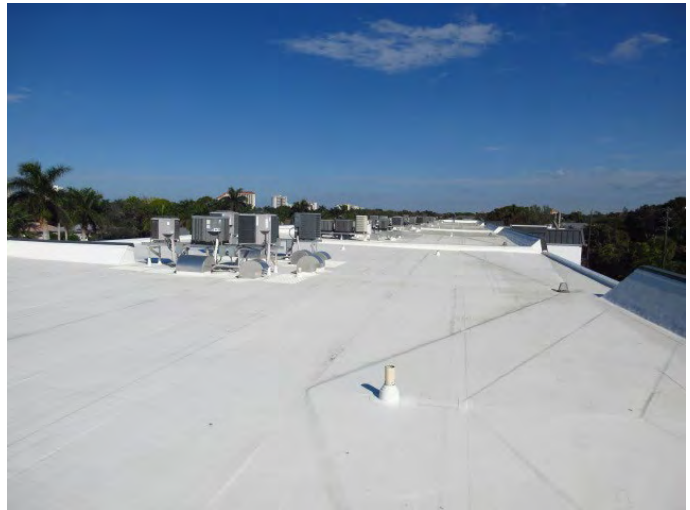
**PHOTO 8**

GENERAL VIEW OF ROOF COVERING

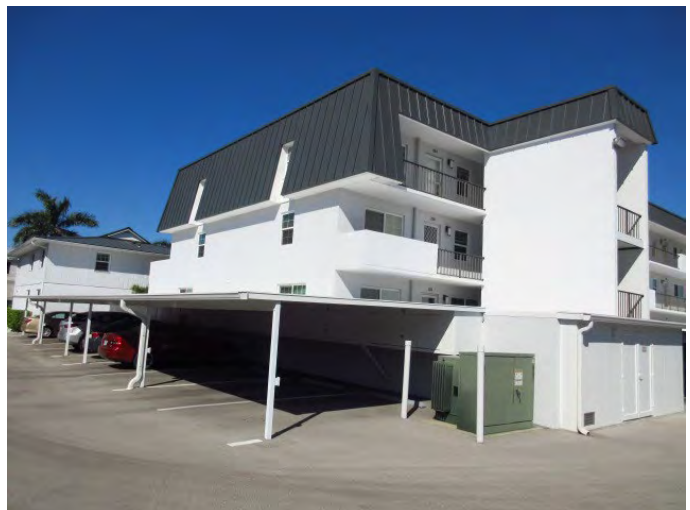
**PHOTO 9**

VIEW OF MANSARD ROOF

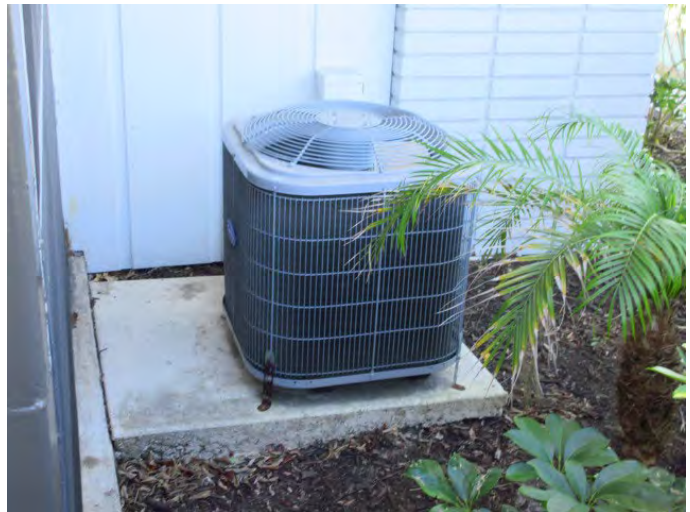
## PHOTO 11

| Item | Description/Observations/Comments |
|---|---|
| HVAC | <p>Cooling and heating are supplied by individual electric forced-air furnaces with split-system air-conditioning condensing units.</p> <p><b>The HVAC equipment was observed to be in good condition with no significant deficiencies noted.</b></p> <p><b>HVAC equipment was reported to be the responsibility of the condominium owners to maintain and replace.</b></p> |

GENERAL VIEW OF HVAC EQUIPMENT

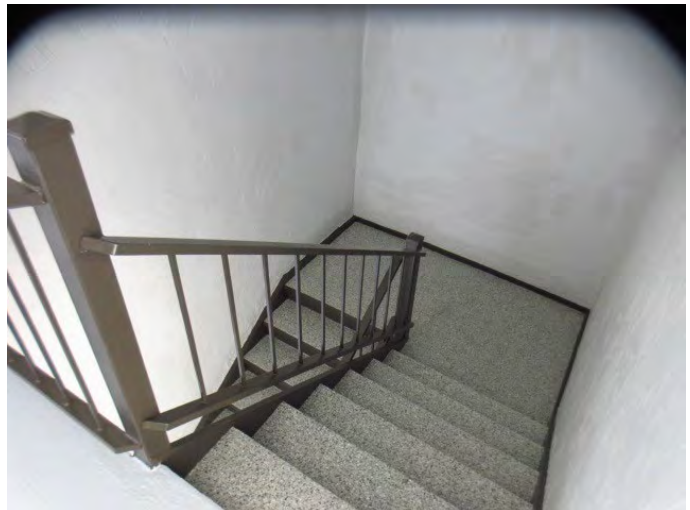
**PHOTO 15**

| Item | Description/Observations/Comments |
|---|---|
| <b>Stairs</b> | <p>The stairs consist of poured concrete with closed risers and aluminum railing.</p> <p><b>The stairs appeared to be in generally good condition, with no significant deficiencies noted. These components are generally addressed in conjunction with the exterior façade painting and waterproofing applications.</b></p> |

VIEW OF STAIRS

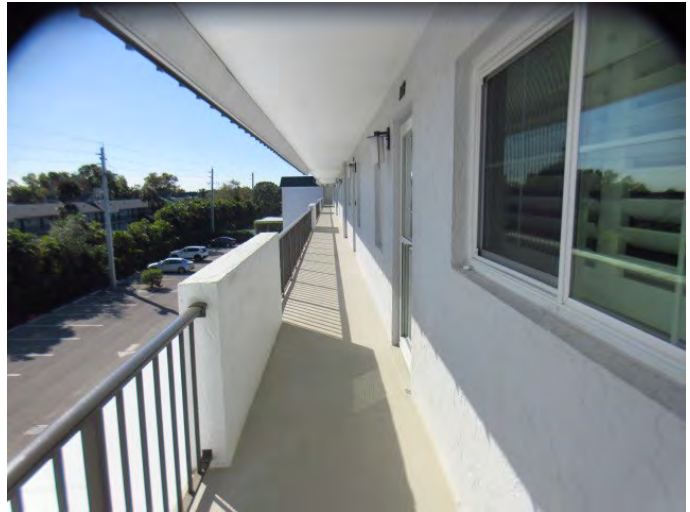
**PHOTO 16**

VIEW OF ELEVATED WALKWAY

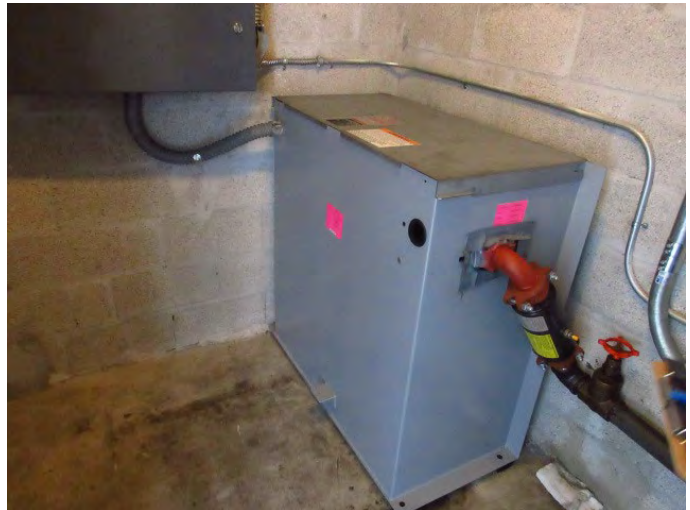
**PHOTO 17**

| Item | Description/Observations/Comments |
|---|---|
| <b>Elevators</b> | <p>The Property is equipped with one hydraulic elevator rated at 2,500 pounds of load capacity.</p> <p><b>The elevator was noted to be in generally good operating condition and reportedly serviced regularly by an elevator service contractor.</b></p> <p><b>We do not anticipate any work needed at this time for the elevator that is in excess of \$10,000. As such it is not considered part of the Reserve Table.</b></p> |

VIEW OF ELEVATOR EQUIPMENT

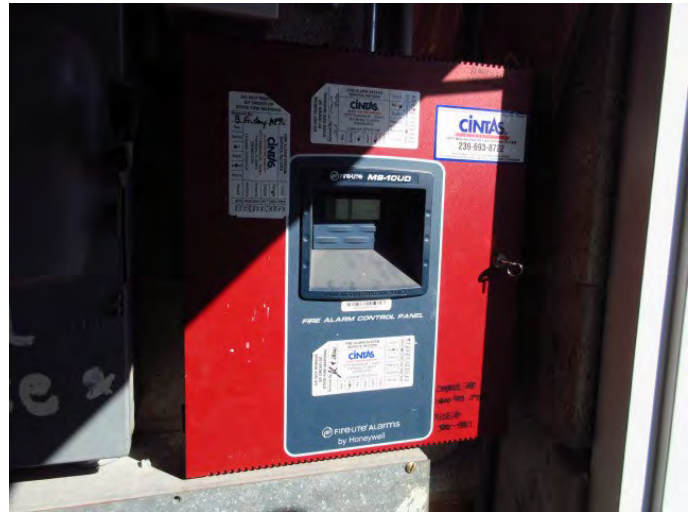
**PHOTO 20**

| Item | Description/Observations/Comments |
|---|---|
| <b>Fire Protection</b> | <p>The Property is equipped with a central fire alarm system. The alarm panel also sounds the alarm and automatically notifies the monitoring service or the fire department in the event of trouble.</p> <p>The common areas are equipped with battery-powered emergency lighting, illuminated exist signs and dry chemical fire extinguishers.</p> <p><b>The central alarm panel was reportedly replaced in 2023. The emergency lighting, exit signs and fire extinguishers were noted to be in good operating condition.</b></p> <p>Fire protection and life safety systems within the dwelling units are reported to be the responsibility of the respective unit owner to maintain and replace.</p> |

VIEW OF CENTRAL ALARM PANEL

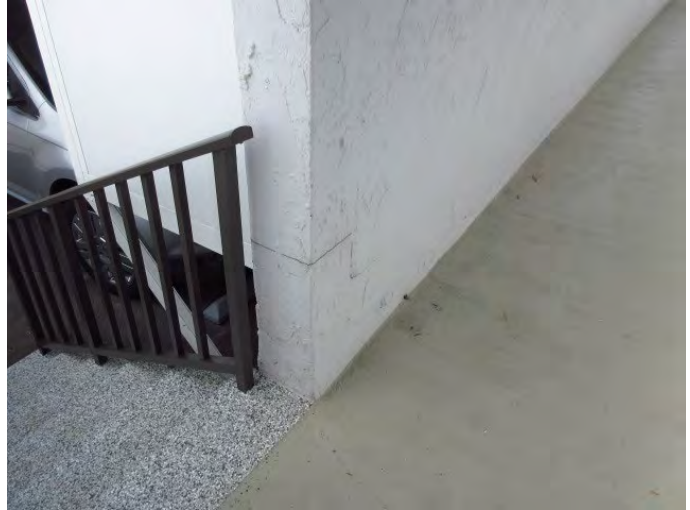
**PHOTO 22**

| Item | Description/Observations/Comments |
|---|---|
| Exterior Walls | <p>The exterior walls typically consist of concrete masonry units (CMU) construction finished with painted stucco.</p> <p>The exterior walls appeared to be in good condition with no significant deficiencies noted. The exterior façades were reportedly repainted and waterproofed in 2017. Based on the Expected useful Life (EUL) of 10 years, periodic repainting and waterproofing of the exterior wall surfaces, including any required repairs, should be anticipated during the evaluation period. Funds have been spread throughout the Replacement Reserves Cost Estimate Table.</p> <p>Please note that the extent of the exterior walls' evaluation did not include sampling or testing, therefore comments made regarding the condition of the façade components are limited to visual observation. Should a more comprehensive investigation be required, further assessment that includes destructive to determine the extent of the deficiencies is recommended.</p> |

VIEW OF CMU STEP-CRACKING

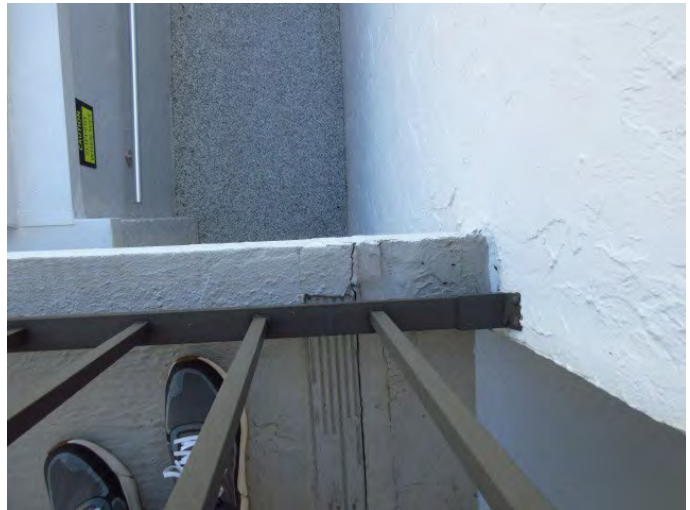
**PHOTO 23**

VIEW OF FAILING EXPANSION JOINT

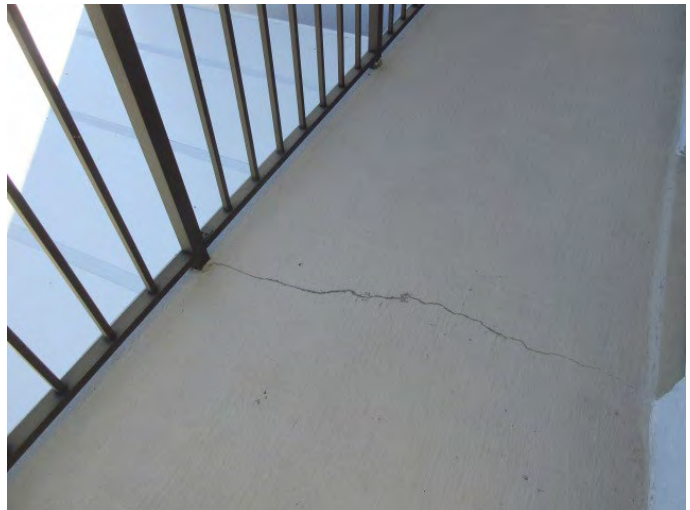
**PHOTO 24**

| Item | Description/Observations/Comments |
|---|---|
| <b>Elevated Walkways</b> | <p>The elevated exterior walkways are concrete and supported by the structural systems of the building. Fall protection is provided by aluminum handrails.</p> <p><b>The elevated walkways appeared to be generally in good condition. These components are generally addressed in conjunction with the exterior façade painting and waterproofing applications.</b></p> |

VIEW OF CRACK AT ELEVATED WALKWAY
